# Management Survey Report Assessment and Register of Asbestos Containing Materials

Croesyceiliog Cricket and  
Rugby Club, The Highway,  
Croesyceiliog, Cwmbran,  
NP44 2HJ

Job No J060859

| Report Type: | | Asbestos Management Survey Report |

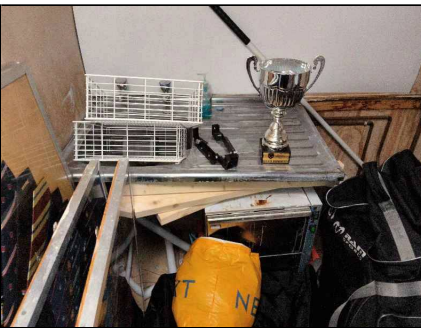
| Inspection Number | Location, position and description | Product | Extent, condition, surface treatment and other comments | Material Risk Rating | | Priority Risk Rating | | Advised Action | Photograph |
|---|---|---|---|---|---|---|---|---|---|
| Inspection 4<br>EW001755 | 1st Floor,<br>1/03 Kitchen/Store,<br>Bitumen acoustic pad to underside of sink | Bitumen | 1no.<br>Low Damage<br>Reinforced<br>composite material | 1 | 3<br>Very<br>Low | 1 | 5<br>Low | Manage<br>ACM in<br>place | |

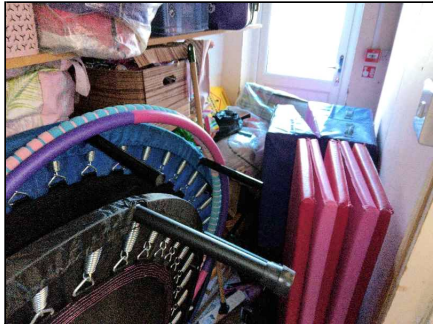
| Inspection Number | Location/Description | Comments | Advised Action | Photograph |
|---|---|---|---|---|
| Inspection 20 Presumed | Ground Floor,<br>G/16 Store,<br>Limited access | Due to stored items | Survey prior to works | |

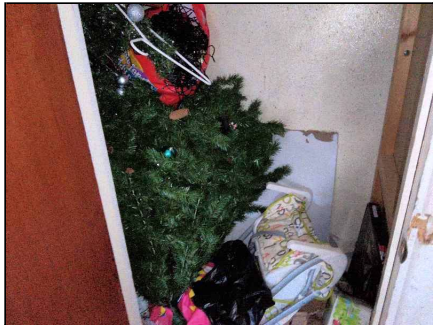
| Inspection Number | Location/Description | Comments | Advised Action | Photograph |
|---|---|---|---|---|
| Inspection 26 Presumed | Ground Floor,<br>G/20 Store,<br>Limited access | Due to stored items | Survey prior to works | |

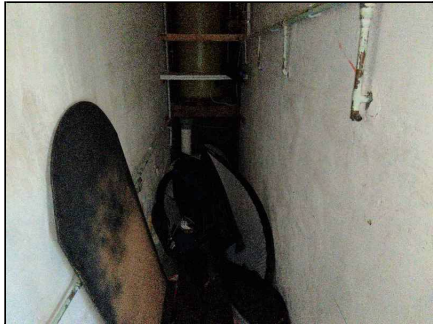
| Inspection Number | Location/Description | Comments | Advised Action | Photograph |
|---|---|---|---|---|
| Inspection 27 Presumed | Ground Floor,<br>G/22 Service Duct,<br>Limited access | Due to stored items | Survey prior to works | |

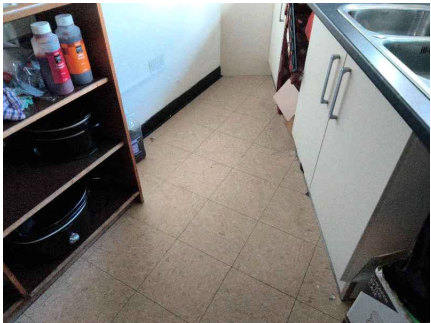
| Inspection Number | Location/Position/Description | Product | Comments | Photograph |
|---|---|---|---|---|
| Inspection 1<br>EW001753 | 1st Floor,<br>1/01 Kitchen,<br>Cream vinyl floor tiles | Vinyl | Approximately 10m <sup>2</sup><br>Good Condition<br>Reinforced composite material | |

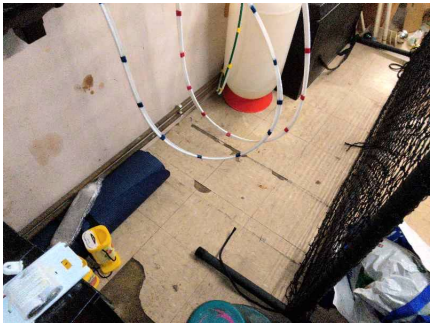
| Inspection Number | Location/Position/Description | Product | Comments | Photograph |
|---|---|---|---|---|
| Inspection 2<br>Strongly Presumed<br>Same As EW001753 | 1st Floor,<br>1/03 Kitchen/Store,<br>Cream vinyl floor tiles | Vinyl | Approximately 14m <sup>2</sup><br>Medium Damage<br>Reinforced composite material | |

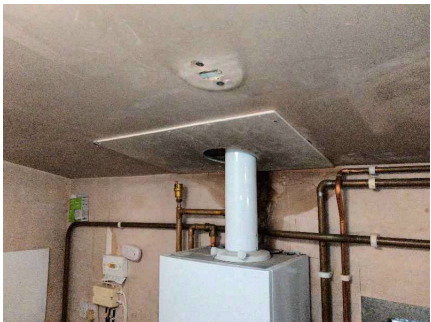
| Inspection Number | Location/Position/Description | Product | Comments | Photograph |
|---|---|---|---|---|
| Inspection 3<br>EW001754 | 1st Floor,<br>1/03 Kitchen/Store,<br>Insulating board closure panel around<br>flue pipe penetration | Insulating board | Approximately 1m <sup>2</sup><br>Low Damage<br>Unsealed | |

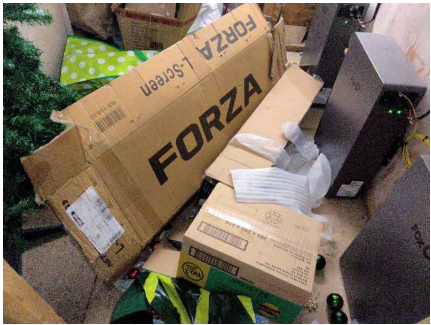
| Inspection Number | Location/Position/Description | Product | Comments | Photograph |
|---|---|---|---|---|
| Inspection 5<br>Strongly Presumed<br>Same As EW001753 | 1st Floor,<br>1/04 Store,<br>Cream vinyl floor tiles | Vinyl | Approximately 4m <sup>2</sup><br>Low Damage<br>Reinforced composite<br>material | |

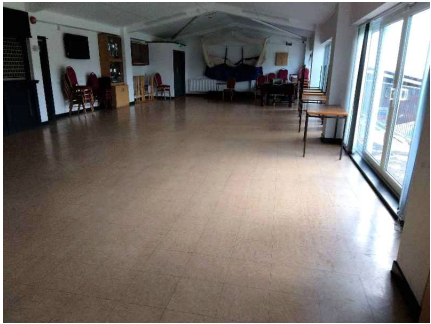
| Inspection Number | Location/Position/Description | Product | Comments | Photograph |
|---|---|---|---|---|
| Inspection 6<br>EW001756 | 1st Floor,<br>1/05 Lounge,<br>Cream vinyl floor tiles and bitumen<br>adhesive | Vinyl and<br>bitumen | Approximately 152m <sup>2</sup><br>Good Condition<br>Reinforced composite<br>material | |

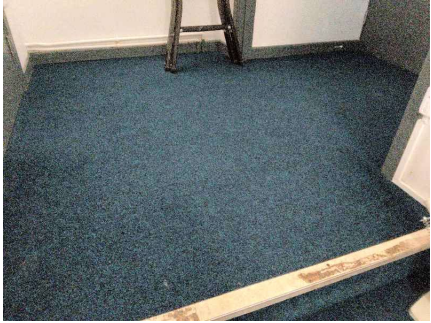
| Inspection Number | Location/Position/Description | Product | Comments | Photograph |
|---|---|---|---|---|
| Inspection 7<br>Strongly Presumed<br>Same As EW001756 | 1st Floor,<br>1/06 Circulation,<br>Cream vinyl floor tiles and bitumen<br>adhesive below carpet | Vinyl and<br>bitumen | Approximately 6m <sup>2</sup><br>Good Condition<br>Reinforced composite<br>material | |

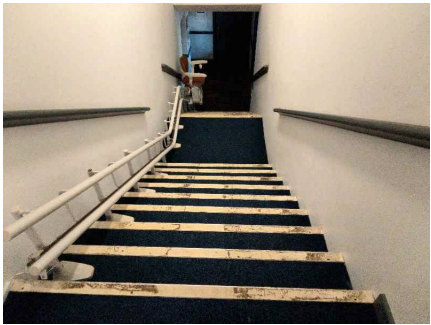
| Inspection Number | Location/Position/Description | Product | Comments | Photograph |
|---|---|---|---|---|
| Inspection 8<br>EW001757 | 1st Floor,<br>1/06 Circulation,<br>White vinyl stair nosings | Vinyl | 19no.<br>Good Condition<br>Reinforced composite material | |

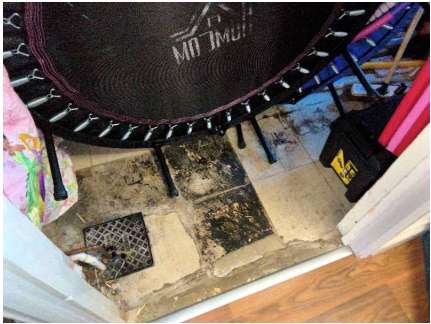
| Inspection Number | Location/Position/Description | Product | Comments | Photograph |
|---|---|---|---|---|
| Inspection 19<br>EW001758 | Ground Floor,<br>G/16 Store,<br>White vinyl floor tiles and bitumen adhesive | Vinyl and bitumen | Approximately 4m <sup>2</sup><br>Medium Damage<br>Reinforced composite material | |

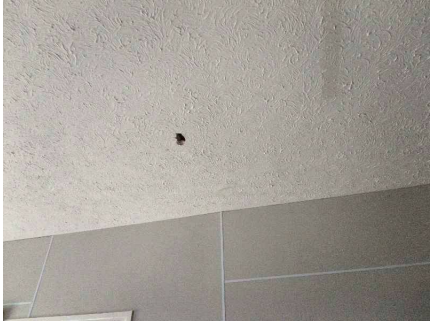
| Inspection Number | Location/Position/Description | Product | Comments | Photograph |
|---|---|---|---|---|
| Inspection 22<br>EW001759 | Ground Floor,<br>G/21 Changing Room,<br>Textured coating to plasterboard ceiling - Swirl | Textured Coating | Approximately 38m <sup>2</sup><br>Medium Damage<br>Reinforced composite material | |

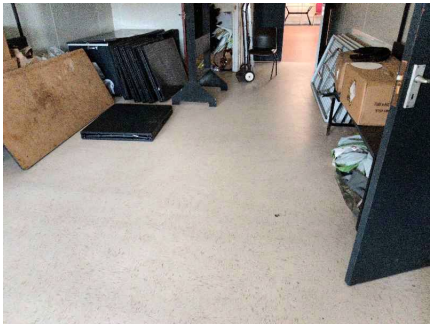
| Inspection Number | Location/Position/Description | Product | Comments | Photograph |
|---|---|---|---|---|
| Inspection 23<br>EW001760 | Ground Floor,<br>G/21 Changing Room,<br>Beige vinyl floor tiles | Vinyl | Approximately 38m <sup>2</sup><br>Low Damage<br>Reinforced composite material | |

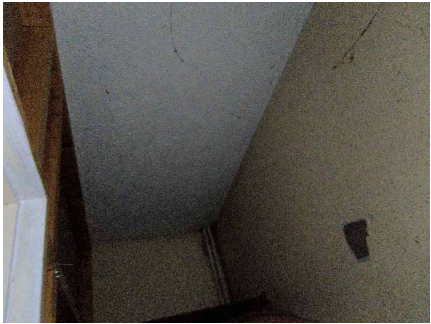
| Inspection Number | Location/Position/Description | Product | Comments | Photograph |
|---|---|---|---|---|
| Inspection 24<br>Strongly Presumed<br>Same As EW001759 | Ground Floor,<br>G/20 Store,<br>Textured coating to plasterboard ceiling - Swirl | Textured Coating | Approximately 2m <sup>2</sup><br>Good Condition<br>Reinforced composite material | |

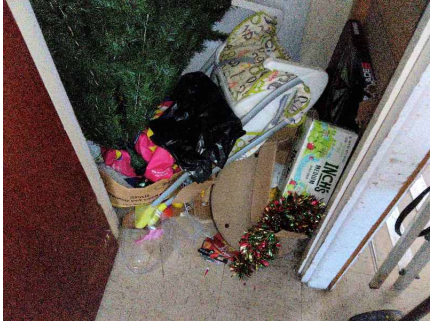
| Inspection Number | Location/Position/Description | Product | Comments | Photograph |
|---|---|---|---|---|
| Inspection 25<br>Strongly Presumed<br>Same As EW001760 | Ground Floor,<br>G/20 Store,<br>Beige vinyl floor tiles | Vinyl | Approximately 2m <sup>2</sup><br>Low Damage<br>Reinforced composite material | |

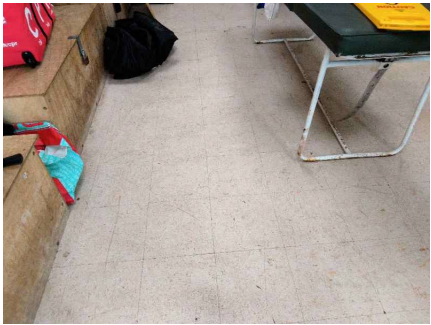
| Inspection Number | Location/Position/Description | Product | Comments | Photograph |
|---|---|---|---|---|
| Inspection 29<br>Strongly Presumed<br>Same As EW001758 | Ground Floor,<br>G/24 Changing Room,<br>White vinyl floor tiles and bitumen<br>adhesive | Vinyl and<br>bitumen | Approximately 028m <sup>2</sup><br>Low Damage<br>Reinforced composite<br>material | |

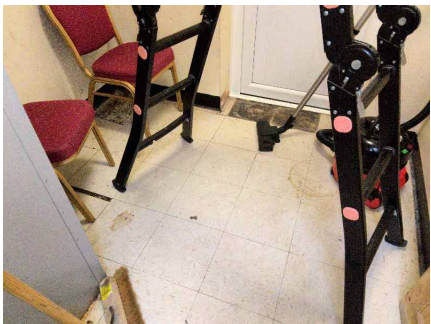
| Inspection Number | Location/Position/Description | Product | Comments | Photograph |
|---|---|---|---|---|
| Inspection 30<br>Strongly Presumed<br>Same As EW001758 | Ground Floor,<br>G/25 Changing Room,<br>White vinyl floor tiles and bitumen<br>adhesive | Vinyl and<br>bitumen | Approximately 4m <sup>2</sup><br>Low Damage<br>Reinforced composite<br>material | |

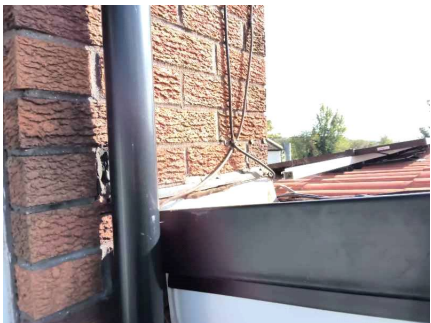
| Inspection Number | Location/Position/Description | Product | Comments | Photograph |
|---|---|---|---|---|
| Inspection 34<br>EW001761 | 1st Floor,<br>External,<br>Black mastic to wall adjacent to<br>balcony | Mastic | Approximately 1m<br>Low Damage<br>Reinforced composite<br>material | |

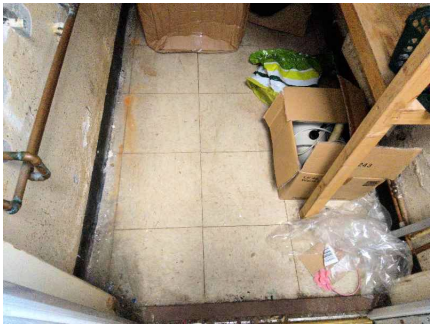
| Inspection Number | Location/Position/Description | Product | Comments | Photograph |
|---|---|---|---|---|
| Inspection 38<br>Strongly Presumed<br>Same As EW001758 | Ground Floor,<br>G/28 Store,<br>White vinyl floor tiles and bitumen<br>adhesive | Vinyl and<br>bitumen | Approximately 2m <sup>2</sup><br>Good Condition<br>Reinforced composite<br>material | |

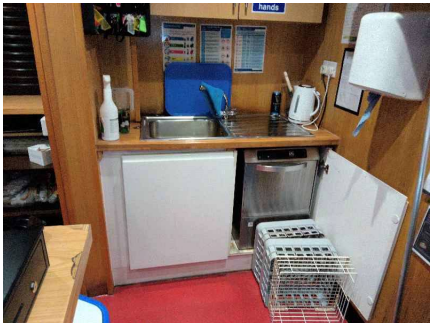
| Inspection Number | Location/Position/Description | Product | Comments | Photograph |
|---|---|---|---|---|
| Inspection 41<br>EW001778 | Ground Floor,<br>G/08 Bar,<br>Bitumen acoustic pads to underside of<br>sink | Bitumen | 2no.<br>Good Condition<br>Reinforced composite<br>material | |

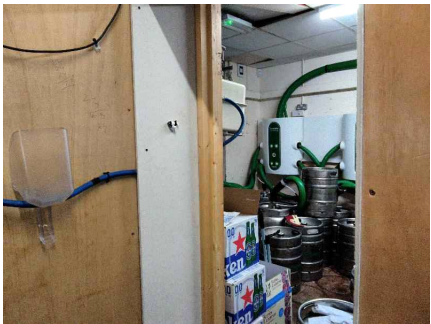
| Inspection Number | Location/Position/Description | Product | Comments | Photograph |
|---|---|---|---|---|
| Inspection 43<br>EW001779 | Ground Floor,<br>G/12 Store,<br>Insulating board panels to door<br>opening | Insulating<br>board | Approximately 2m <sup>2</sup><br>Low Damage<br>Unsealed | |

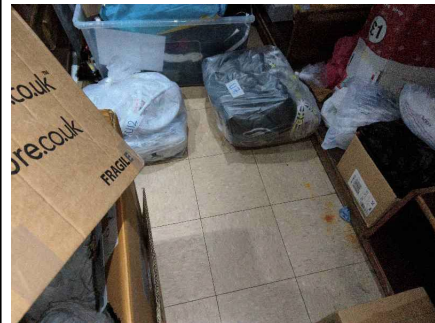
| Inspection Number | Location/Position/Description | Product | Comments | Photograph |
|---|---|---|---|---|
| Inspection 45<br>Strongly Presumed<br>Same As EW001753 | 1st Floor,<br>1/02 Bar,<br>Cream vinyl floor tiles | Vinyl | Approximately 4m <sup>2</sup><br>Good Condition<br>Reinforced composite<br>material | |
