# Management Survey Report Assessment and Register of Asbestos Containing Materials

Croesyceiliog Cricket and  
Rugby Club, The Highway,  
Croesyceiliog, Cwmbran,  
NP44 2HJ

Job No J060859

| Report Type: | | Asbestos Management Survey Report |

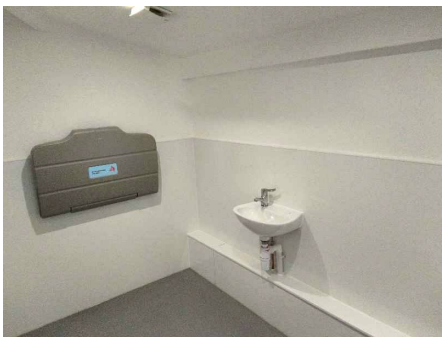
| Inspection Number | Location | Photograph |
|---|---|---|
| Inspection 9 | 1st Floor,<br>1/07 Accessible WC<br>Plasterboard ceiling, masonry/plasterboard walls with uPVC panels, fixed non suspect sheet vinyl, timber door and frame, fixed plasterboard/uPVC boxing, modern ceramic sanitaryware, plastic soil, copper pipework, plastic waste pipes | |

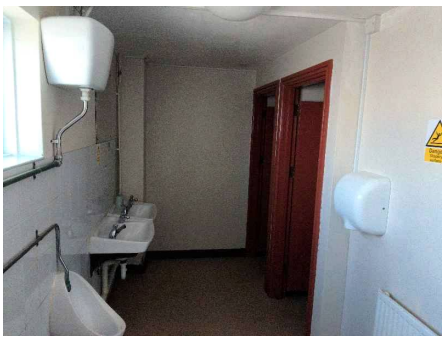
| Inspection Number | Location | Photograph |
|---|---|---|
| Inspection 10 | Ground Floor,<br>G/01 Male WC<br>Plasterboard ceiling, masonry walls with ceramic tiles, fixed non suspect sheet vinyl, non suspect vinyl skirtings, timber doors and frames, uPVC window frame, ceramic tiled window sill, modern ceramic sanitaryware, plastic soil pipes, plastic waste pipes, copper pipework, plastic trunking, fixed plasterboard boxing | |

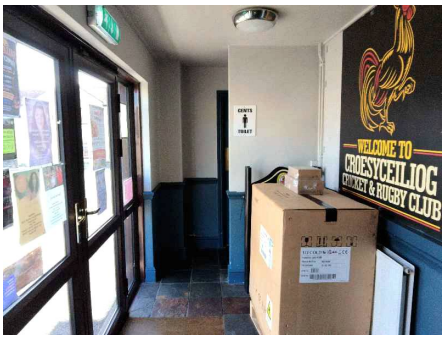
| Inspection Number | Location | Photograph |
|---|---|---|
| Inspection 11 | Ground Floor,<br>G/02 Foyer<br>Plasterboard ceiling, masonry walls with decorative paper and timber beading, ceramic tiles/carpet to concrete floor, timber skirting boards, uPVC/timber doors and frames, modern electrical unit mounted directly to masonry wall, plastic trunking, copper pipework | |

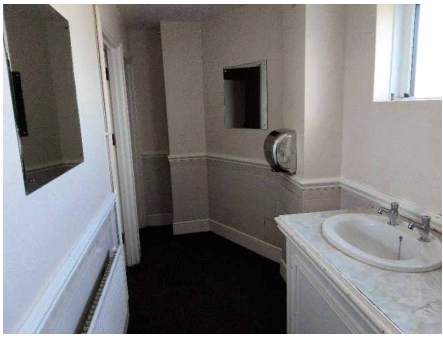
| Inspection Number | Location | Photograph |
|---|---|---|
| Inspection 12 | Ground Floor,<br>G/03 Female WC<br>Plasterboard ceiling, masonry walls with ceramic tiles and timber beading, fixed non suspect sheet vinyl, carpet to concrete floor, non suspect vinyl skirtings, timber doors and frames, uPVC window frame, modern ceramic sanitaryware, plastic soil pipes, plastic waste pipes, copper pipework, plastic trunking, timber constructed vanity unit, fixed timber boxing | |

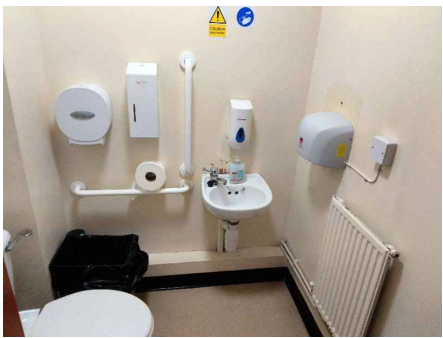
| Inspection Number | Location | Photograph |
|---|---|---|
| Inspection 13 | Ground Floor,<br>G/04 Accessible WC<br>Plasterboard ceiling, masonry walls, fixed non suspect sheet vinyl, non suspect vinyl skirtings, timber door and frame, modern ceramic sanitaryware, plastic soil pipes, plastic waste pipe, copper pipework, fixed plasterboard/timber boxing | |

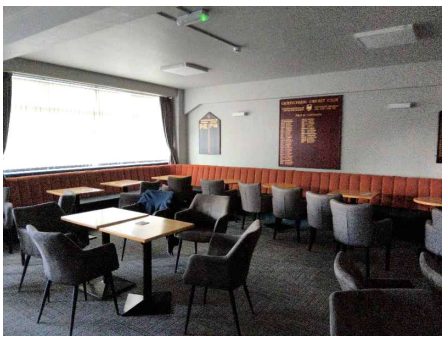
| Inspection Number | Location | Photograph |
|---|---|---|
| Inspection 14 | Ground Floor,<br>G/06 Lounge<br>Plasterboard ceiling, masonry/plasterboard walls with decorative paper and timber beading, fixed carpet tiles and non suspect sheet vinyl, timber skirting boards, timber/uPVC doors and frames, metal roller shutters, uPVC window frames, timber window sills, timber constructed bar, timber constructed seating, plastic trunking, fixed plasterboard boxing | |

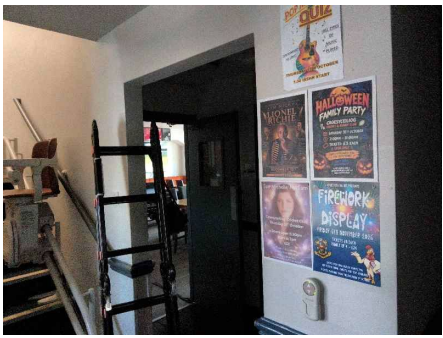
| Inspection Number | Location | Photograph |
|---|---|---|
| Inspection 15 | Ground Floor,<br>G/07 Circulation<br>Concrete soffit, steel beams and columns, plastic pipework insulated with foam, plastic soil pipe, timber access hatches, plasterboard ceiling, masonry/plasterboard walls on timber framework studwork with decorative paper and timber beading, ceramic floor tiles, timber skirting boards, timber doors and frames | |

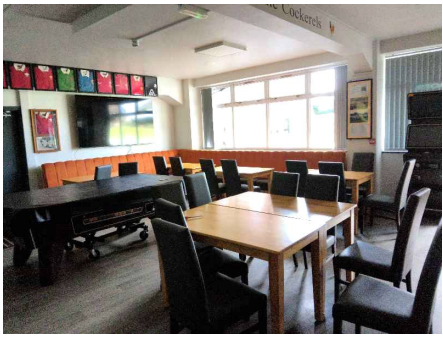
| Inspection Number | Location | Photograph |
|---|---|---|
| Inspection 16 | Ground Floor,<br>G/09 Bar Area<br>Plasterboard ceiling, masonry/plasterboard walls, fixed non suspect sheet vinyl, timber skirting boards, timber/uPVC doors and frames, metal roller shutters, uPVC window frames, timber window sills, timber constructed bar, timber constructed seating, plastic trunking, fixed timber/plasterboard boxing | |

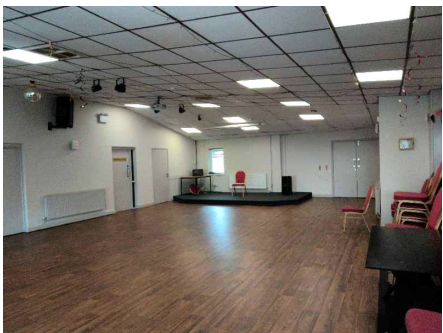
| Inspection Number | Location | Photograph |
|---|---|---|
| Inspection 17 | Ground Floor,<br>G/14 Lounge Area<br>Non suspect felt to underside of roof, timber/steel beams, copper pipework with plastic sleeves to wall penetrations, redundant metal perimeter grid, plastic/metal ducting with non suspect mastic seals, loose MMMF insulation, MMMF suspended ceiling tiles with metal grid, masonry walls with decorative paper and timber panels, plasterboard/timber walls on timber studwork with decorative paper and timber panels, fixed non suspect sheet vinyl, timber skirting boards, timber doors and frames, metal roller shutters, uPVC window frames, uPVC window sills, timber constructed bar, timber constructed stage, plastic trunking, fixed timber boxing | |

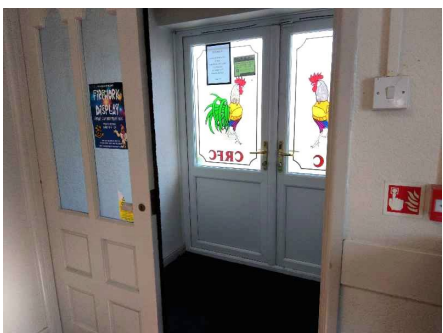
| Inspection Number | Location | Photograph |
|---|---|---|
| Inspection 18 | Ground Floor,<br>G/15 Foyer<br>Non suspect felt to underside of roof, timber/steel beams, loose MMMF insulation, MMMF suspended ceiling tiles with metal grid, masonry walls with decorative paper, plasterboard/timber walls on timber studwork with decorative paper, carpet to timber floor, timber skirting boards, timber/uPVC doors and frames | |

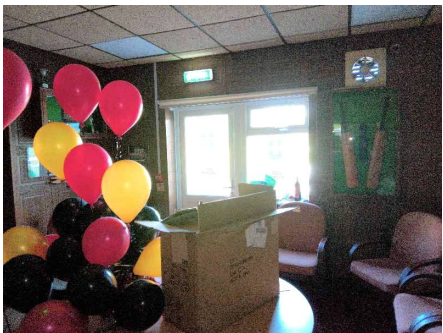
| Inspection Number | Location | Photograph |
|---|---|---|
| Inspection 21 | Ground Floor,<br>G/17 Committee Room<br>Non suspect felt to underside of roof, timber/steel beams, copper pipework, plastic/metal ducting with non suspect mastic seals, metal flue pipe, loose MMMF insulation, MMMF suspended ceiling tiles with metal grid, timber shadow batten, masonry walls with timber panels, carpet to concrete floor, timber skirting boards, timber/uPVC doors and frames, uPVC window frame, timber window sill, plastic trunking | |

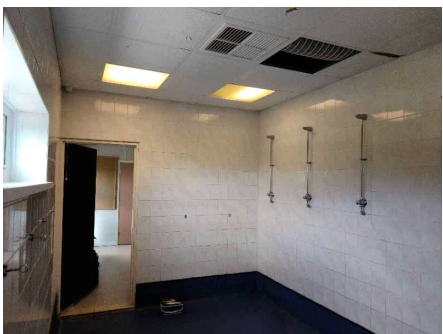
| Inspection Number | Location | Photograph |
|---|---|---|
| Inspection 28 | Ground Floor,<br>G/23 Showers<br>Non suspect felt to underside of roof, timber beams, copper pipework, plastic/metal ducting with non suspect mastic seals, MMMF suspended ceiling tiles with metal grid, masonry walls with ceramic tiles, fixed non suspect sheet vinyl, timber door and frame, uPVC window frame, uPVC window sill | |

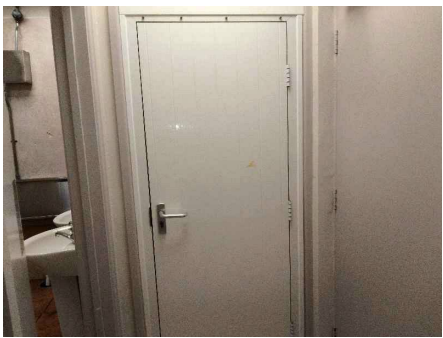
| Inspection Number | Location | Photograph |
|---|---|---|
| Inspection 31 | Ground Floor,<br>G/26 Circulation<br>Non suspect felt to underside of roof, timber beams, copper/plastic pipework, MMMF suspended ceiling tiles with metal grid, masonry/plasterboard walls, fixed non suspect sheet vinyl, timber skirting boards, timber doors and frames | |

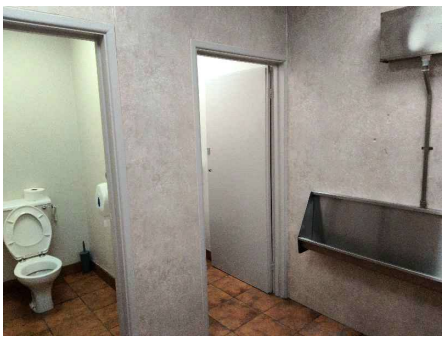
| Inspection Number | Location | Photograph |
|---|---|---|
| Inspection 32 | Ground Floor,<br>G/27 Male WC<br>Non suspect felt to underside of roof, timber beams, copper/plastic pipework, timber floor boards, timber joists, MMMF suspended ceiling tiles with metal grid, masonry walls with uPVC panels, ceramic floor tiles, timber doors and frames, modern ceramic sanitaryware, plastic soil pipes, plastic waste pipes, fixed timber boxing | |

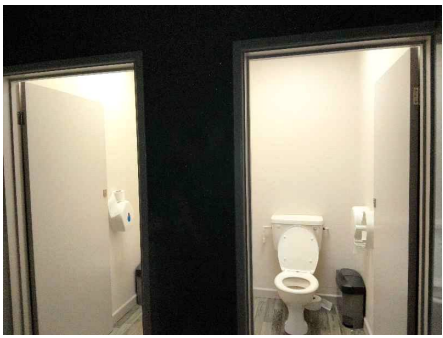
| Inspection Number | Location | Photograph |
|---|---|---|
| Inspection 33 | Ground Floor,<br>G/29 Female WC<br>Non suspect felt to underside of roof, timber beams, copper/plastic pipework, timber floor boards, timber joists, MMMF suspended ceiling tiles with metal grid, masonry walls with uPVC panels, fixed non suspect sheet vinyl, timber doors and frames, modern ceramic sanitaryware, plastic soil pipes, plastic waste pipes, timber constructed vanity unit | |

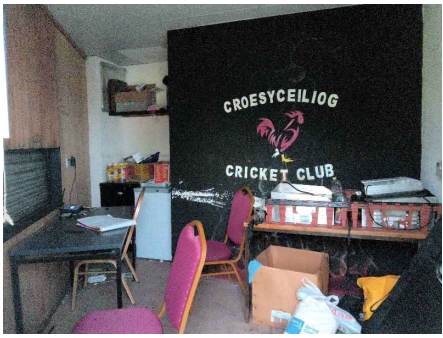
| Inspection Number | Location | Photograph |
|---|---|---|
| Inspection 35 | Ground Floor,<br>G/18 Marker Room<br>Non suspect felt to underside of roof, timber joists, plasterboard suspended ceiling tiles with metal grid, masonry walls, timber wall panels, carpet on self levelling compound to concrete floor, uPVC door and frame, metal roller shutter, plastic trunking | |

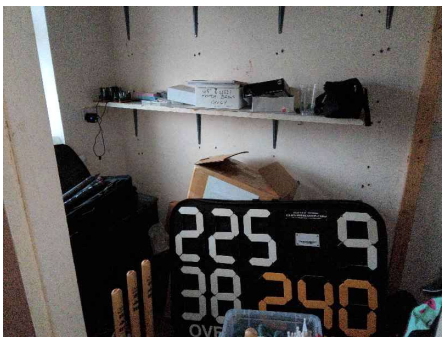
| Inspection Number | Location | Photograph |
|---|---|---|
| Inspection 36 | Ground Floor,<br>G/19 Store<br>Non suspect felt to underside of roof, timber joists, masonry walls, carpet to concrete floor, timber doors and frames, uPVC window frame and sill, metal pipework | |

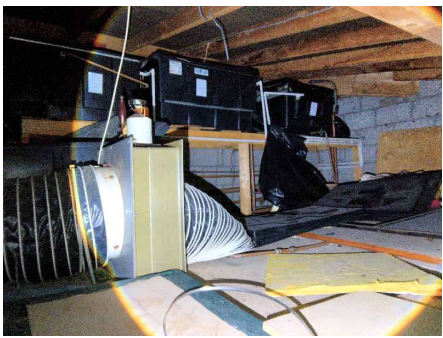
| Inspection Number | Location | Photograph |
|---|---|---|
| Inspection 37 | Ground Floor,<br>G/30 Tank Room (Above G/29)<br>Non suspect felt to underside of roof, timber joists, steel/timber beams, breeze block/brick walls, timber floor boards, plastic water tanks on timber plinths, metal/plastic pipework, metal and plastic ducting with non suspect mastic seals | |

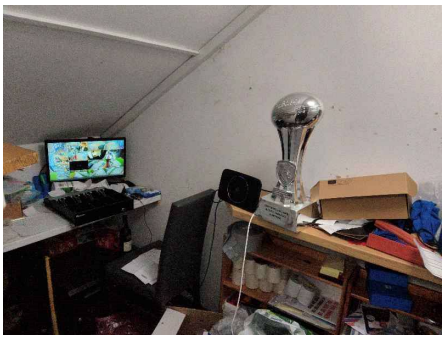
| Inspection Number | Location | Photograph |
|---|---|---|
| Inspection 39 | Ground Floor,<br>G/10 Store<br>Plasterboard underpinning, masonry walls, carpet to concrete floor, timber skirting boards, timber door and frame, plastic trunking | |

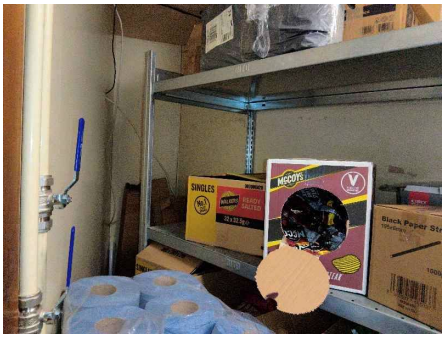
| Inspection Number | Location | Photograph |
|---|---|---|
| Inspection 40 | Ground Floor,<br>G/05 Store<br>Plasterboard ceiling, masonry walls, carpet to concrete floor, timber skirting boards, timber door and frame, metal pipework, plastic trunking | |

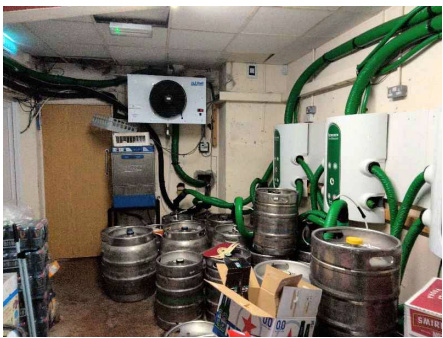
| Inspection Number | Location | Photograph |
|---|---|---|
| Inspection 42 | Ground Floor,<br>G/11 Cellar<br>Non suspect felt to underside of roof, timber joists, steel/timber beams, loose MMMF insulation, MMMF/plasterboard suspended ceiling tiles with metal grid, masonry walls with timber panels, plasterboard closure panel to wall opening, concrete floor, timber/uPVC doors and frames, metal/plastic pipework insulated with foam, electrical equipment mounted directly to timber wall panel, plastic/metal trunking | |

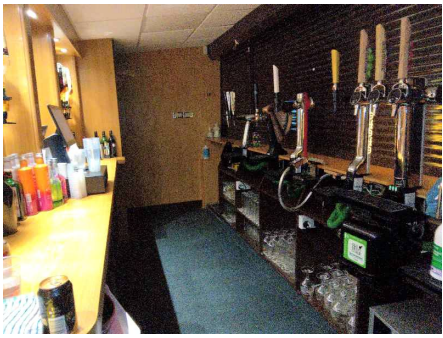
| Inspection Number | Location | Photograph |
|---|---|---|
| Inspection 44 | Ground Floor,<br>G/13 Bar<br>Non suspect felt to underside of roof, timber joists, MMMF suspended ceiling tiles with metal grid, masonry walls, timber wall panels on timber studwork, fixed non suspect sheet vinyl, timber door and frame, metal roller shutter, timber constructed bar, plastic trunking, copper pipework, plastic waste pipe, non suspect acoustic pads to underside of sink dated 2017 | |
